Investigation of a Site with PCB DNAPL in Fractured Rock

A Case Study in Site Characterization

GE Hudson Falls Plant Site

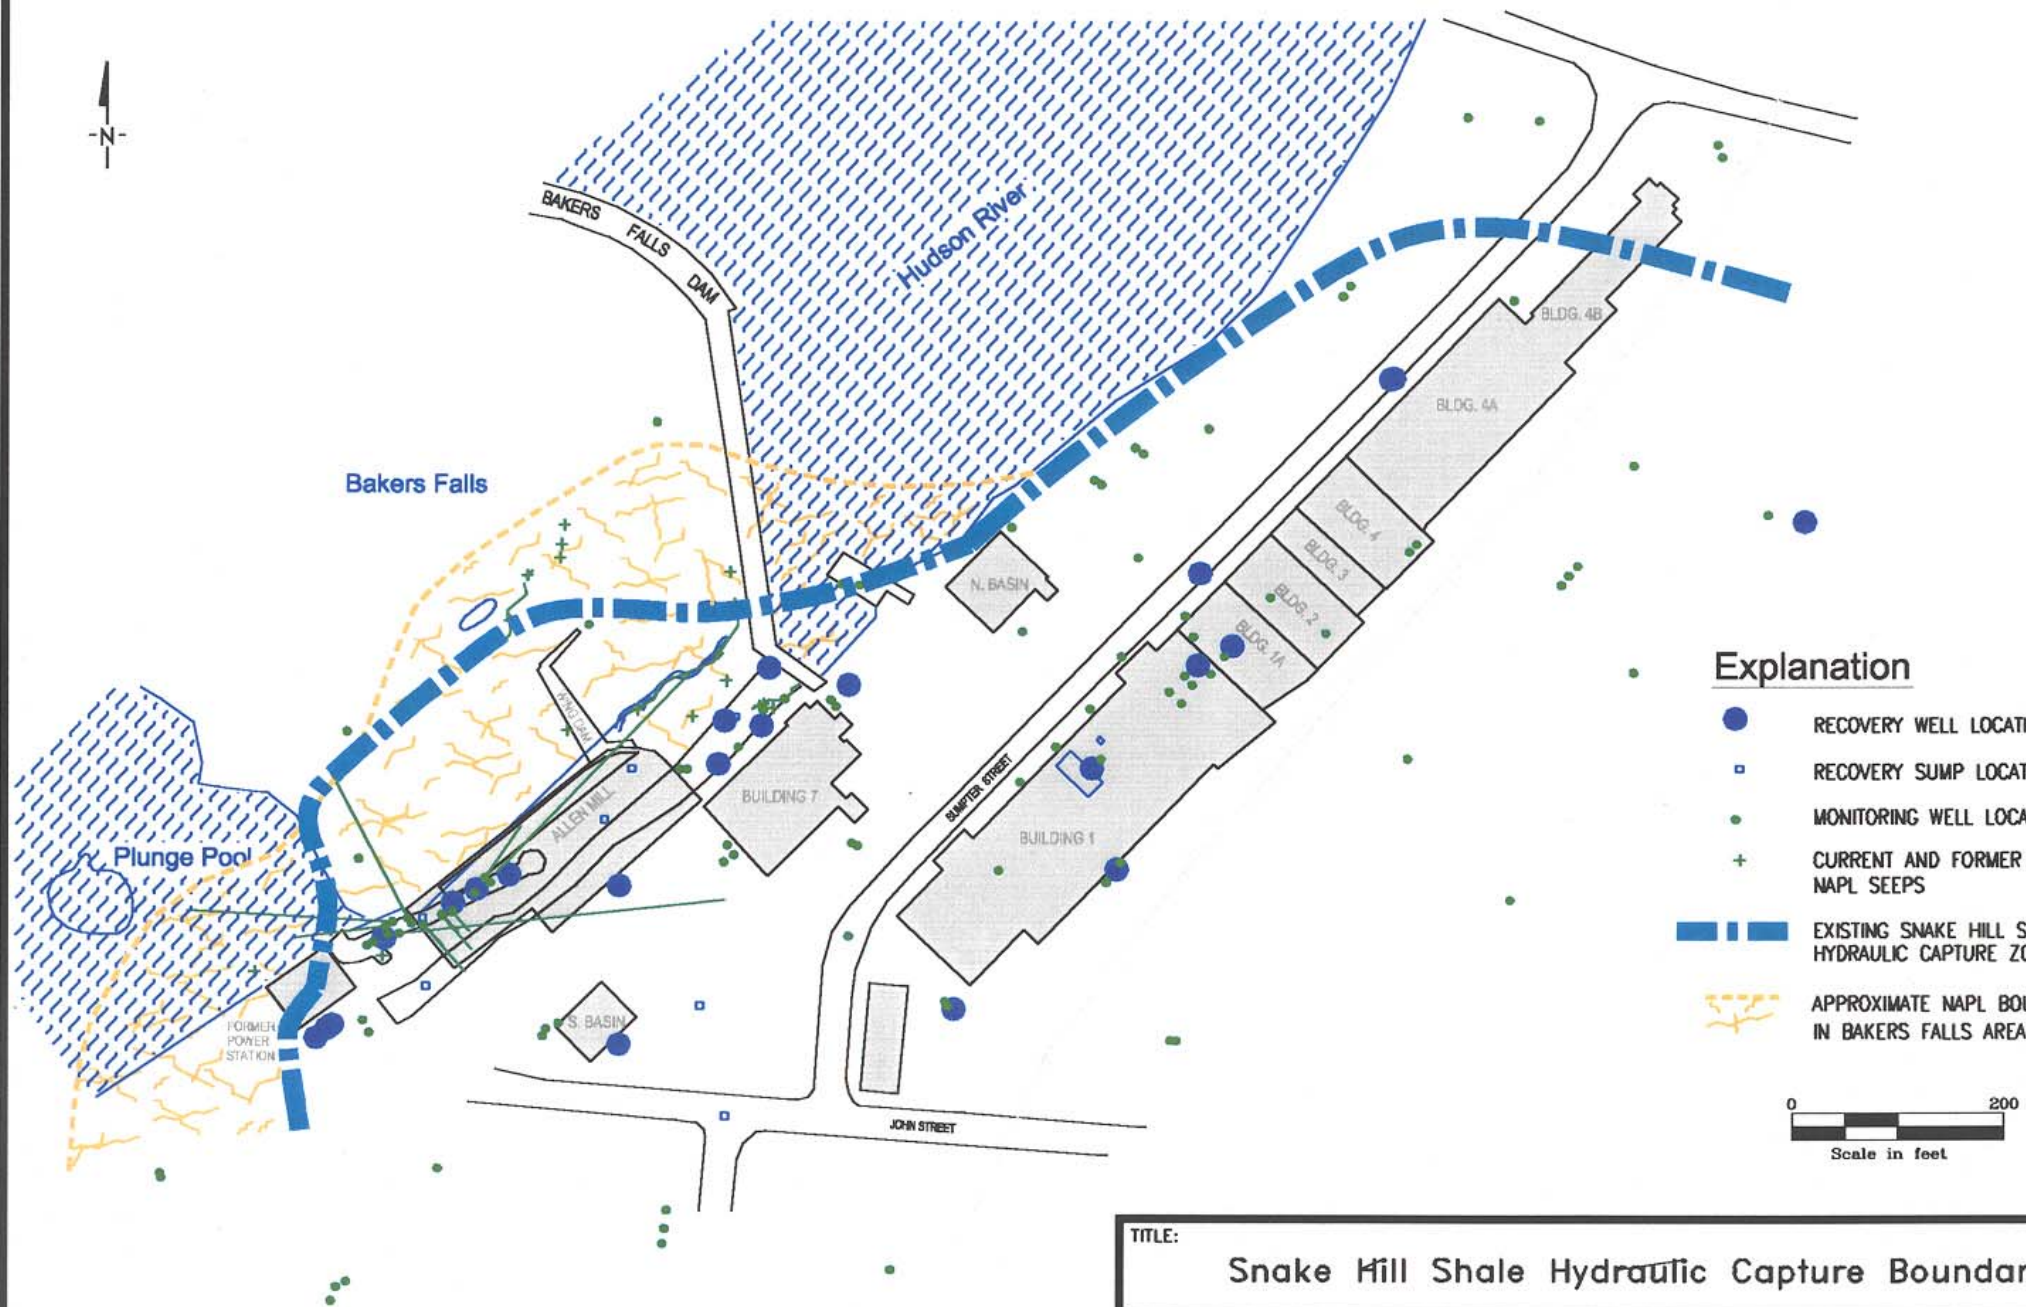
TITLE:		Snake Hill Shale Hydraulic Capture Boundary	
LOCATION:		GE Hudson Falls

- Extent of contamination (DNAPL and dissolved) defined at depth, and to the south
- Zone of hydraulic capture established in the Snake Hill shale along the Hudson River to the west, intercepting 90% of flow from site
- Approximately 70% of DNAPL recovered was from the Middle Snake Hill shale
